AVIATION INVESTIGATION REPORT

A00A0185

RUNWAY OVERRUN

FOKKER F-28 C-GKCR

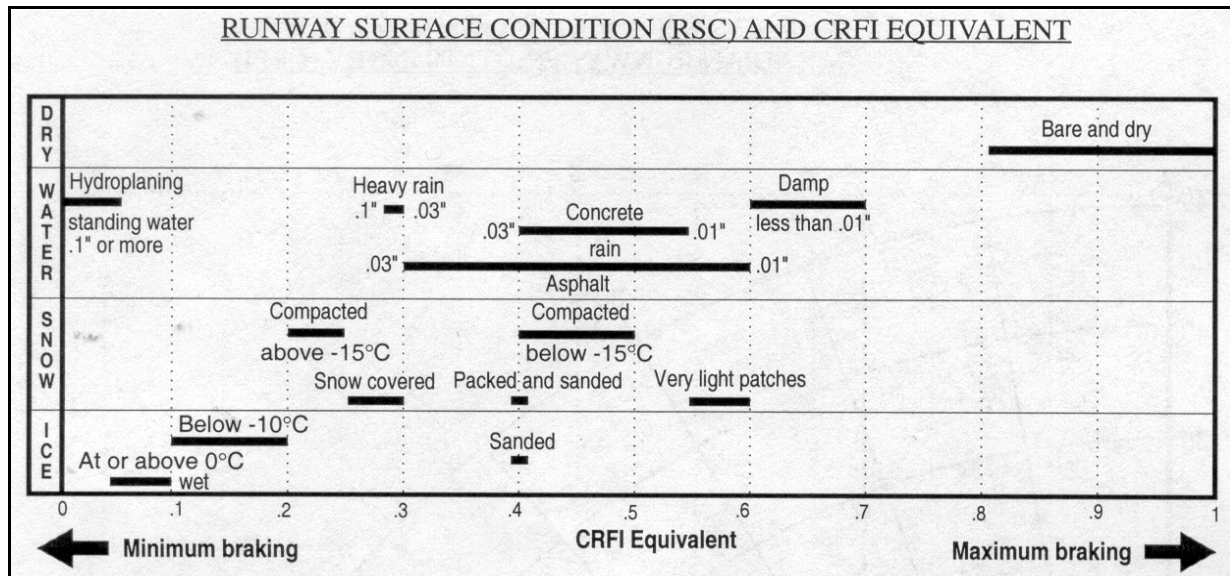
Figure 1. RSC and CRFI equivalent.

Canada (Figure 1). Using this chart, crews can choose a CRFI equivalent from among typical runway surface contaminants such as water, snow, or ice. This chart does not, however, have a CRFI equivalent for slush contamination.

The RSC for runway 09 reported to the crew about 10 minutes before arrival indicated that the runway centreline was 50% covered in thin slush. The CRFI equivalence chart does not give a value for runways that are partially or fully contaminated with slush. The crew, therefore, had no means of estimating a CRFI equivalence for the landing on runway 09. About 8 minutes before landing, the crew indicated to the FSS specialist that they had the option to land on either runway and requested that the vehicles be cleared from all runways. This suggests that the crew continued to believe that both runways would be usable for landing and that they were not aware that the slush contamination was accumulating on runway surfaces. Seven minutes before landing, the RSC reported to the crew for runway 15/33 indicated that the entire runway surface was covered in slush, eliminating 15/33 as a usable runway. This report could have served as an indication that slush was also accumulating rapidly on runway 09; however, this fact was not made clear to the crew.

1. The Canadian runway friction index equivalence chart does not indicate a value for runways contaminated with slush. Crews have no means of readily assessing the effects of slush on an aircraft's stopping performance.
2. Runway surface condition reports do not indicate if a contaminant, such as slush, is accumulating or the rate of such accumulation.

On 20 June 2002, a second advisory (A020014-1) was forwarded to TC suggesting that TC consider establishing CRFI equivalents for slush contamination.
